Christchurch, New Zealand Earthquake sequence in 2010-2011

Situations after the 2011 Christchurch earthquake (Mw=6.1)

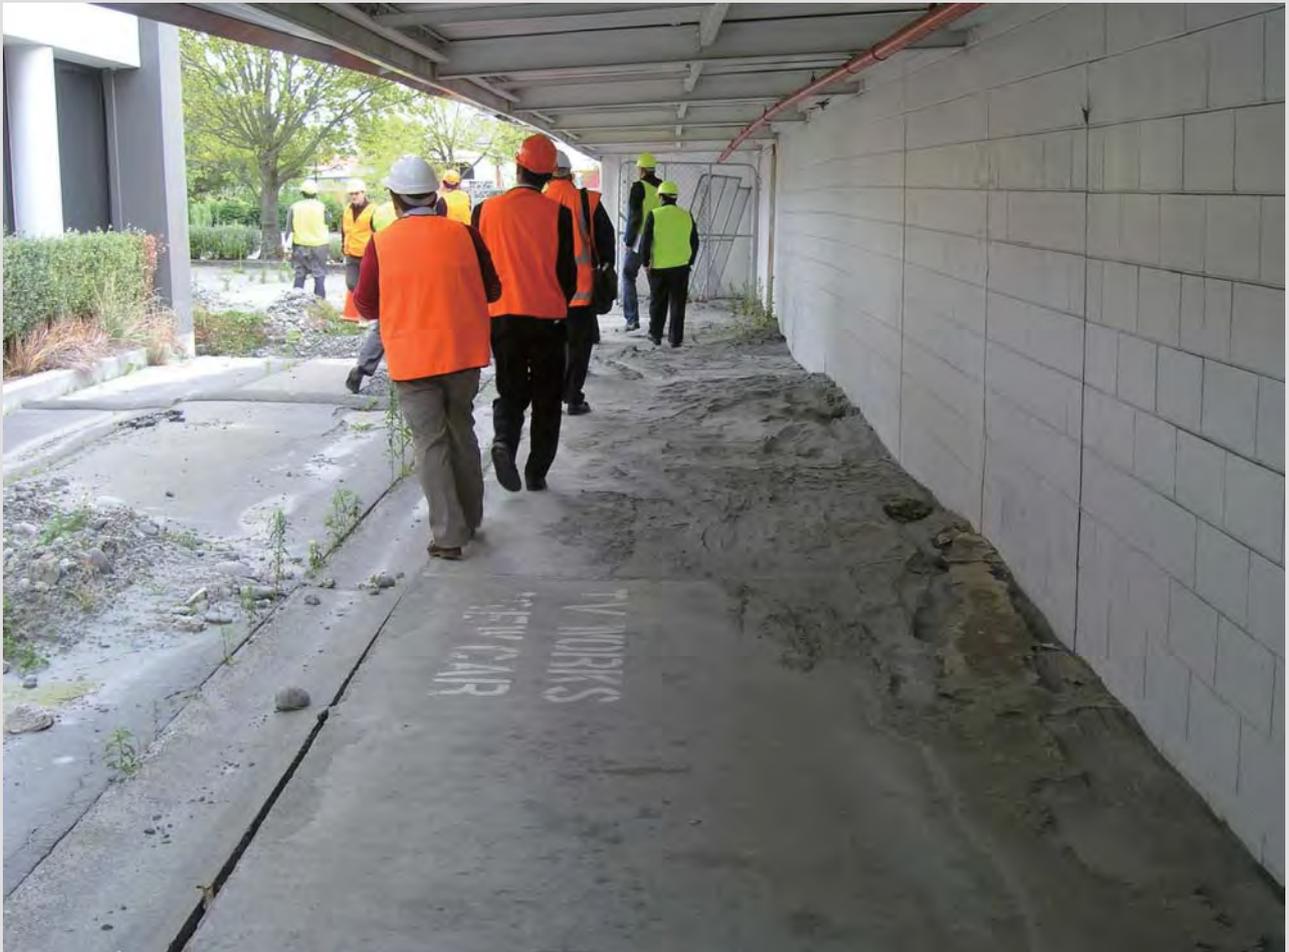
Going to be demolished,
as per March 2012, one
year after the disaster

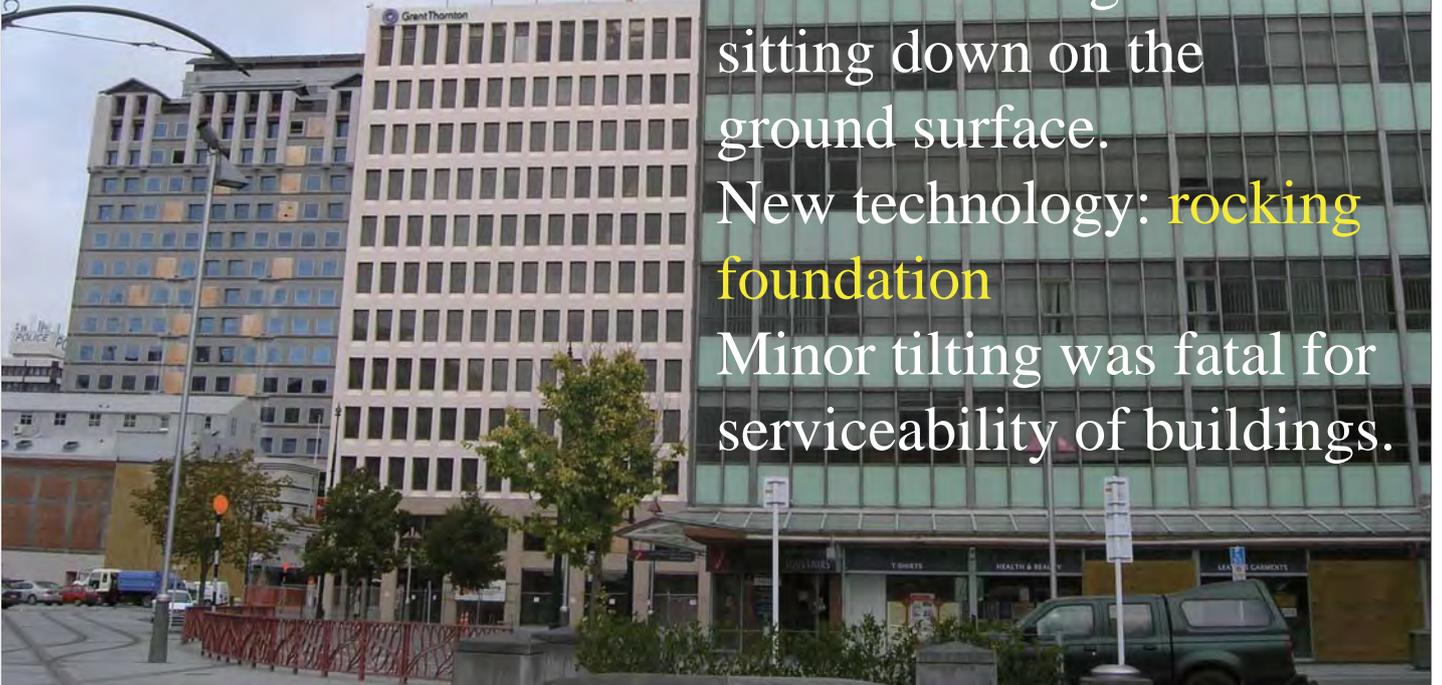
Recent buildings were
sitting down on the
ground surface.

New technology: **rocking
foundation**

Minor tilting was fatal for
serviceability of buildings.

- **Rigid or elastic ground** was the original idea: no plastic deformation remains after earthquakes (no tilting).
- Even in soft soil, rocking makes symmetric deformation on front and back sides → building sinks vertically only.
- Actually, buildings tilted in one direction: eccentricity during tilting.
- **Minor tilting was fatal to the serviceability of buildings.**
- Earthquake insurance money was sufficient to demolish those buildings.

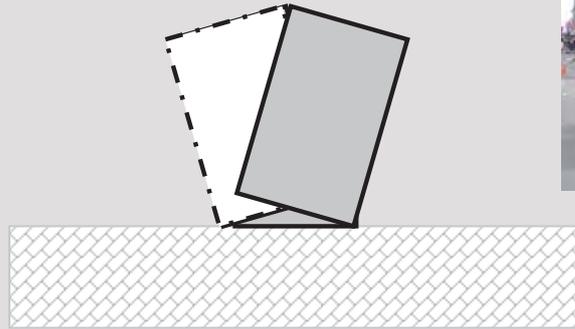
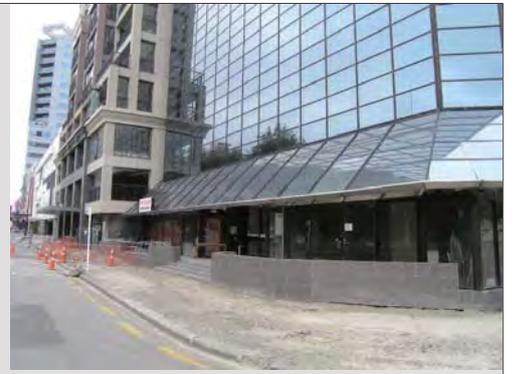
What is rocking foundation?

- Building is simply sitting at the surface of the ground.
- During strong shaking, building rocks back and forth.
- This motion absorbs the earthquake energy and reduces the dynamic response of the superstructure.
- In Christchurch, this idea worked well; no structural damage (and most probably no significant damage in non-structural members) in superstructures.
- What about the foundations?

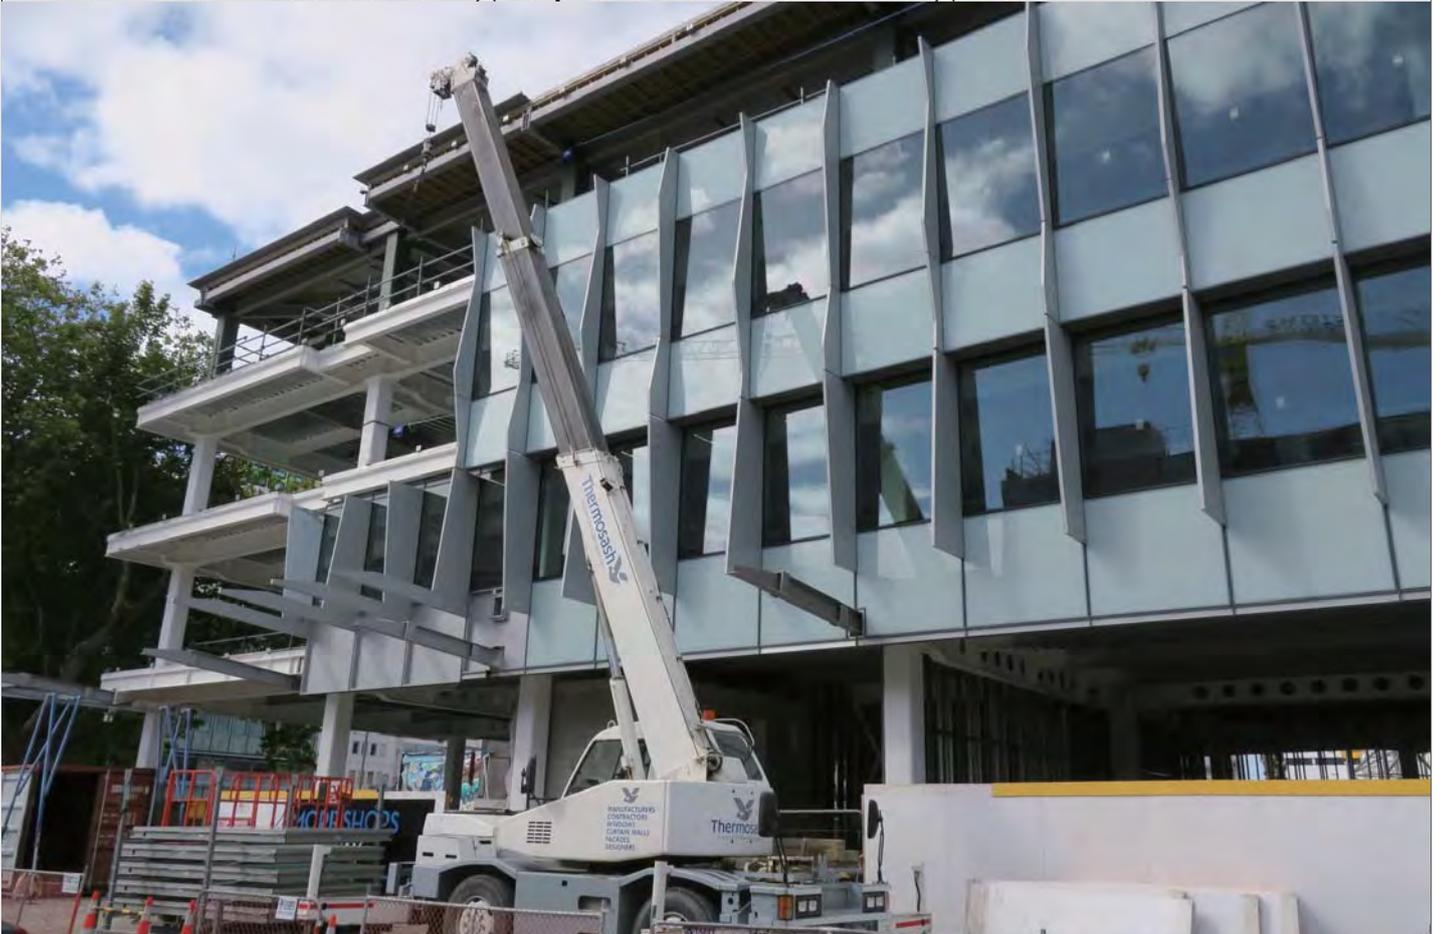
Low and wide building is preferred: no rocking risk.

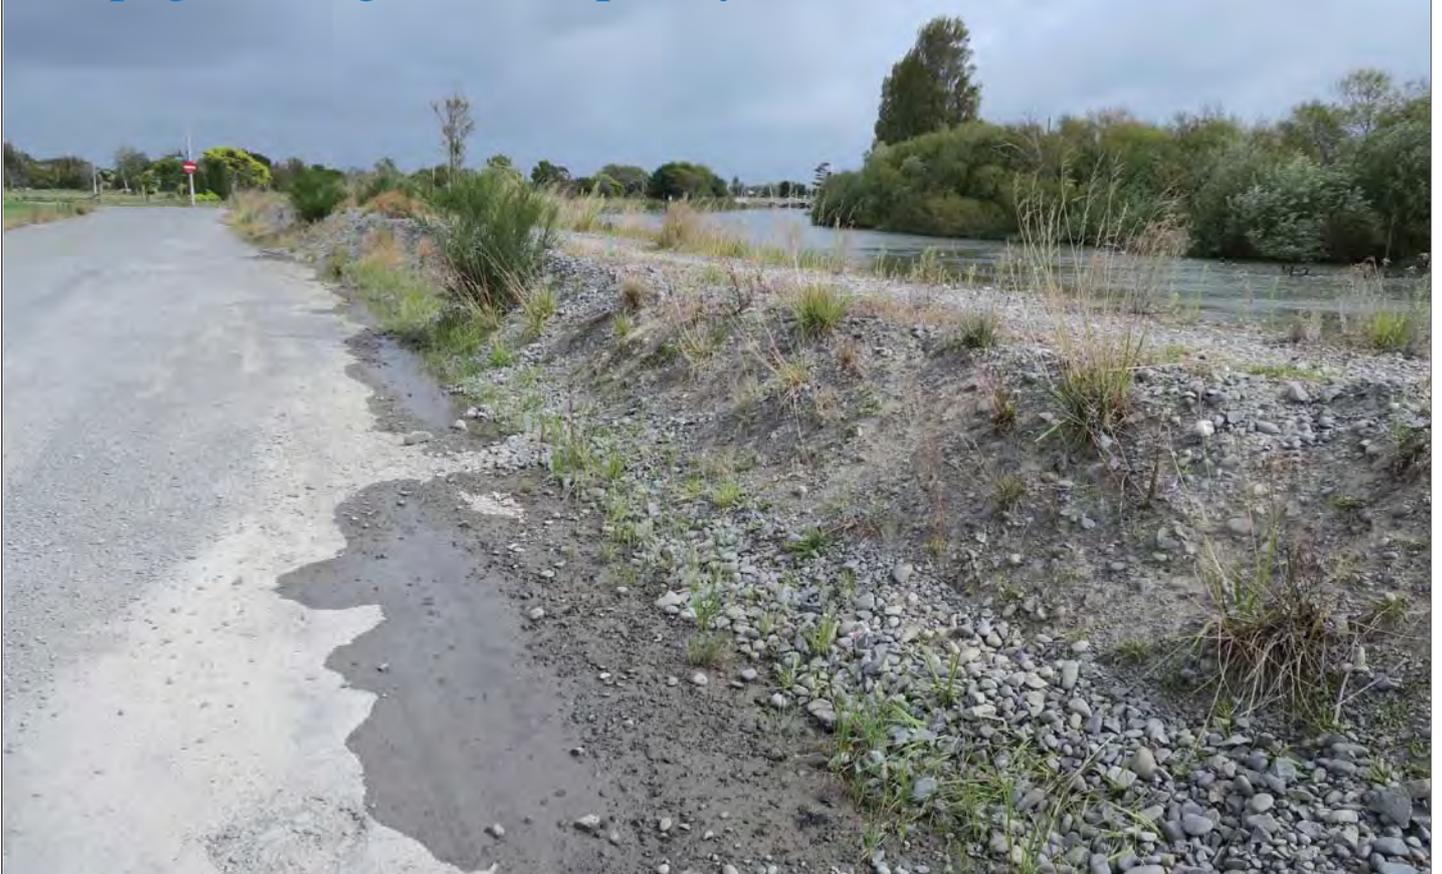
Coseismic subsidence

Now sea (and river) water level is higher than before.

Seepage through the temporary river levee (March 2016)

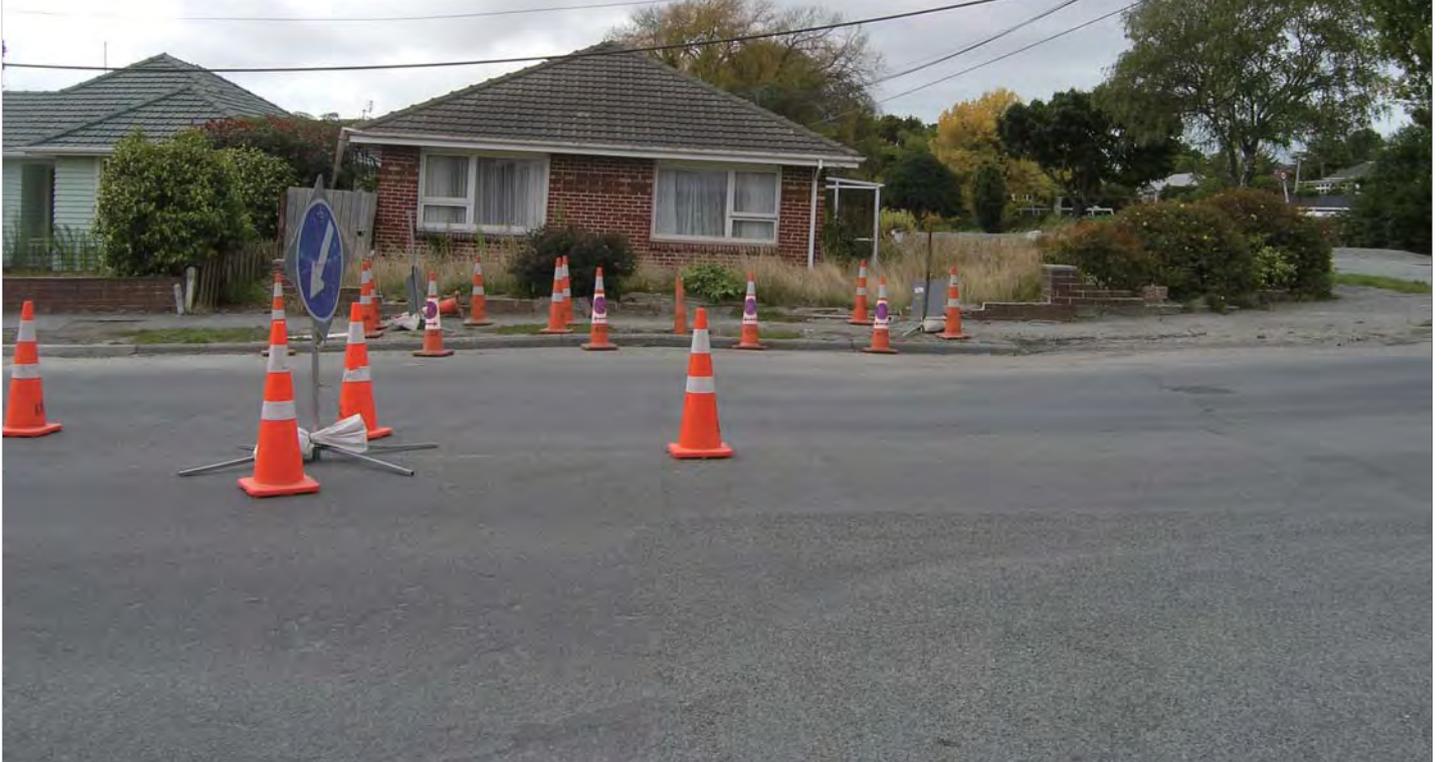
Liquefaction occurred in both business district and residential land in former deltaic area.

Same sites got liquefied 3 times or more.

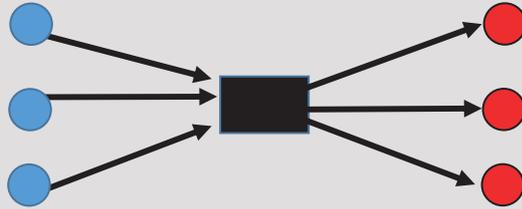
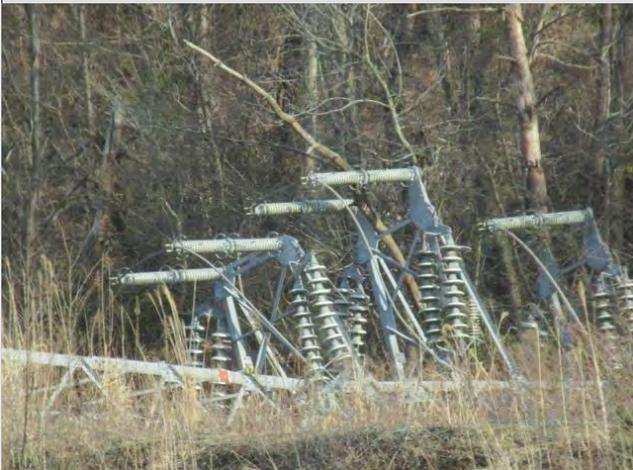
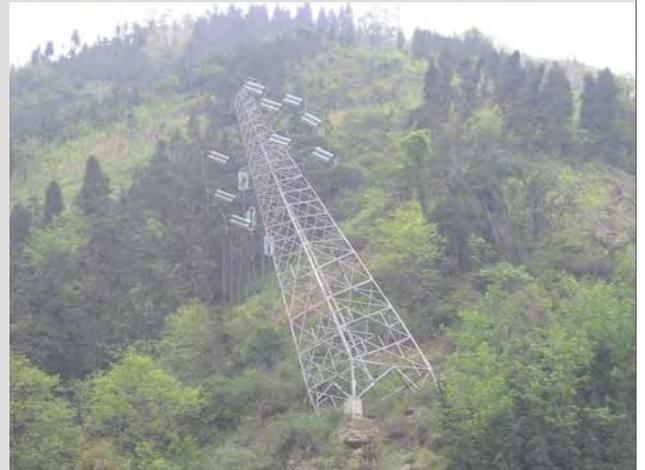
1999 Chi-chi earthquake in Taiwan (Magnitude $M_w=7.6$)

Node of trunk electric power lines was damaged

→ no power supply in huge area
